# Inspection Report

123 Any Way St, Lake Jackson, TX 77566

**Inspection Date** October 13, 2016

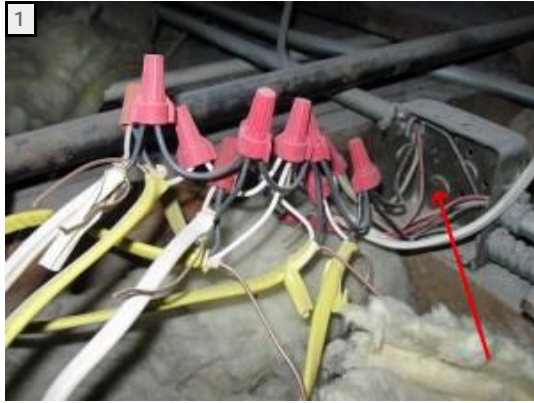
B.2.a. Electric service panel(Attached Garage): Amateur wiring

**Amateur wiring**

**Location** Attached Garage  
**Impact** The amateur wiring renders the electrical supply unsafe  
**Suggested Action** Have improved by a licensed electrician

Wires out of junction box

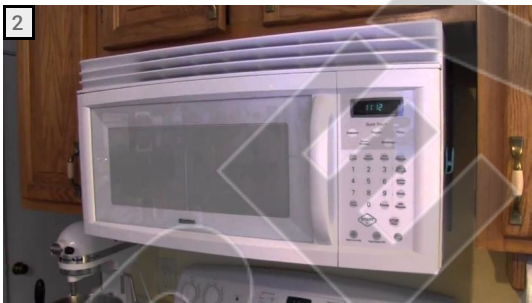
E.3.a. Microwave Oven(Kitchen): Not Working

<b>Not Working</b>
Location	Kitchen
Suggested Action	Replace the unit as desired

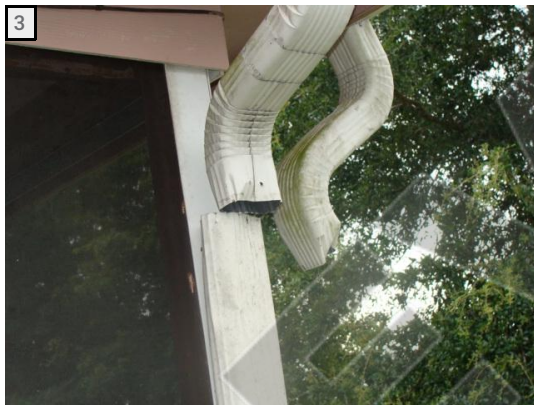
F.1.a. Downspout(Exterior: Ground View): Fasteners are not held tight to the building

**Fasteners are not held tight to the building**

**Location** Exterior: Ground View  
**Impact** Without proper fasteners, the downspout could further pull away  
**Suggested Action** Resecure or replace the fasteners  
**Other Information** Fasteners hold the downspout secure to the building to avoid disconnection from the gutter

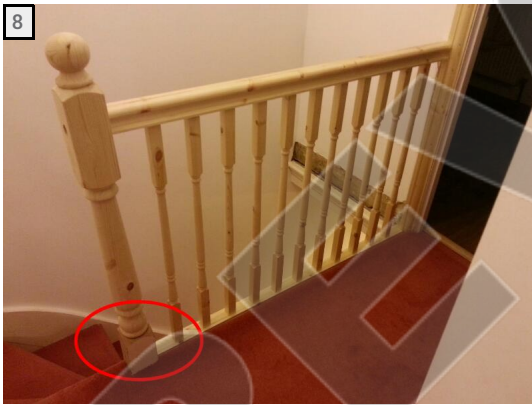
I.16.a. Stair(Hallway and Stairs): Newels are loose

**Newels are loose**

**Location** Hallway and Stairs  
**Impact** Reduces the stability of the stair rail system limiting its capacity to stop or reduce the extent of a fall  
**Suggested Action** Secure the newels

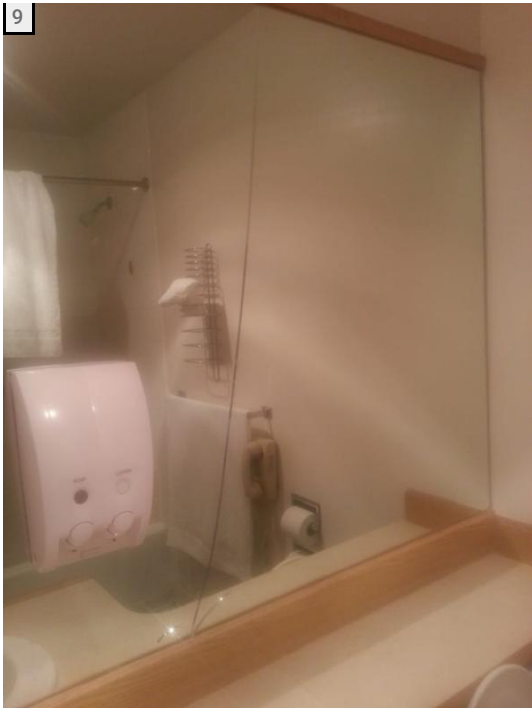
**Mirror is cracked**

**Location** 2nd Bathroom  
**Impact** The cracks expose sharp edges and affects aesthetics  
**Suggested Action** Replace the mirror
